# BGB REPAIRS & REFURBISHMENTS

# BGB REPAIR - SERVICE

# Gamesa – Slip Ring Repair

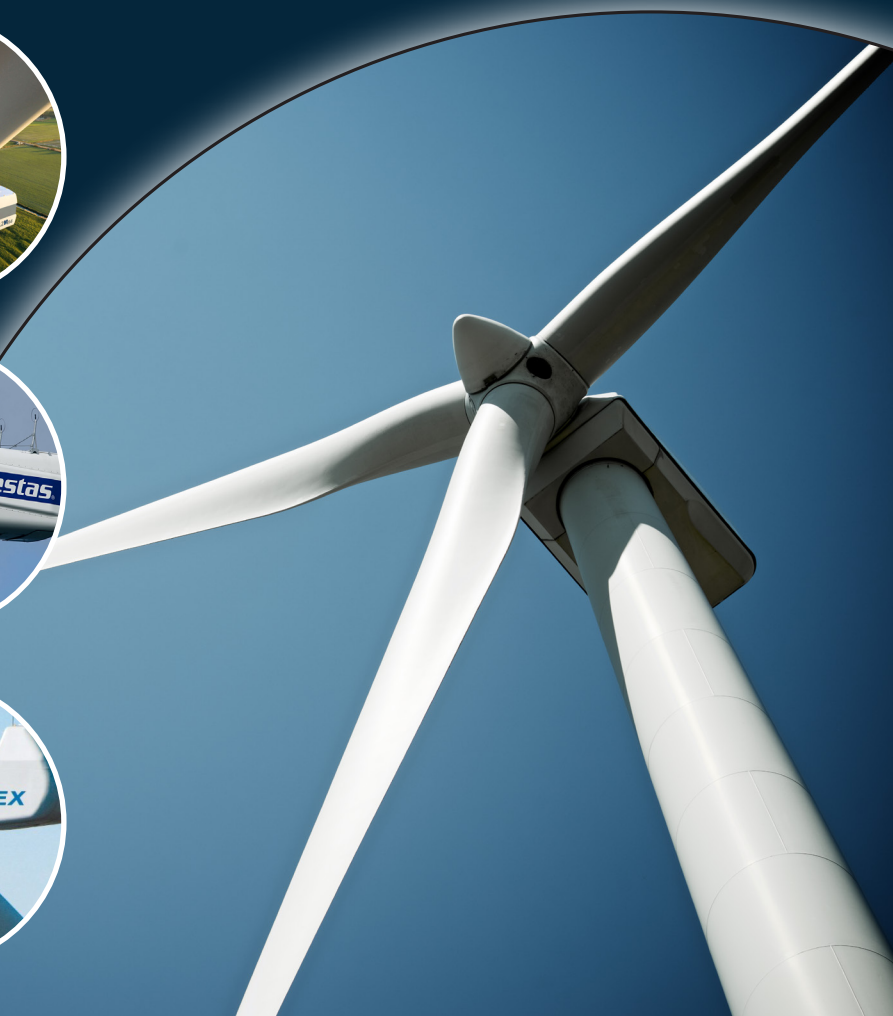
The most common failure mode observed is from **oil ingress** or from damaged gold wire brushes.

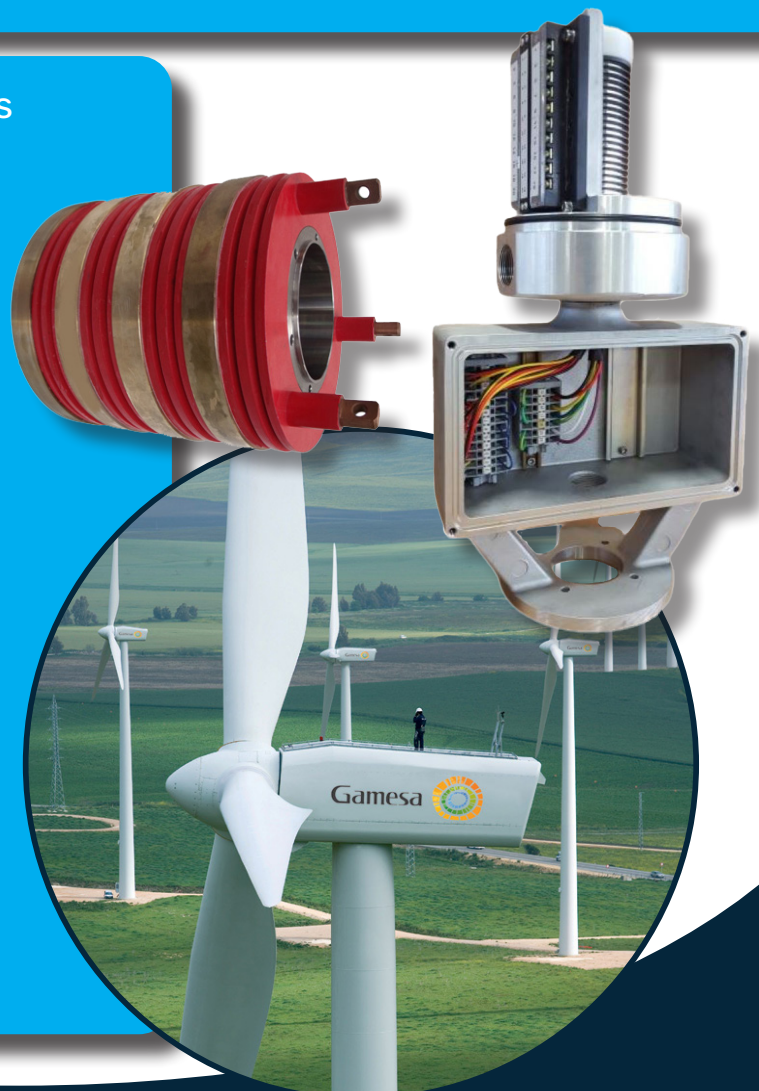
The most common failure mode observed is from **water ingress** during storms. During stop, the rotor is stationary which leads to water leaking from the hub through the hollow shaft into the slip ring on the 400V channels.

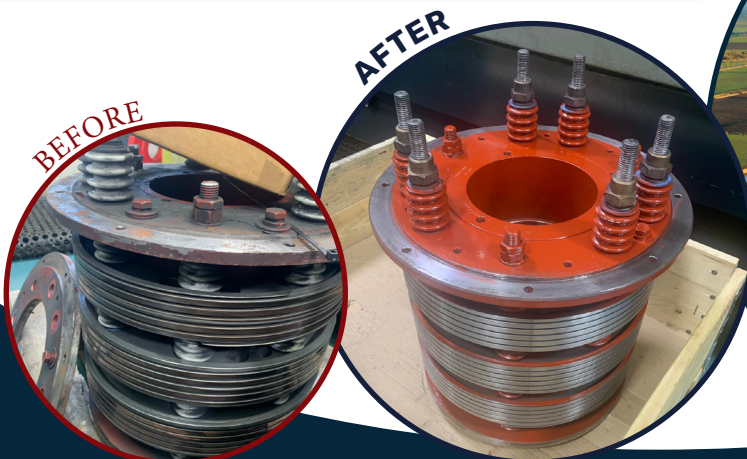
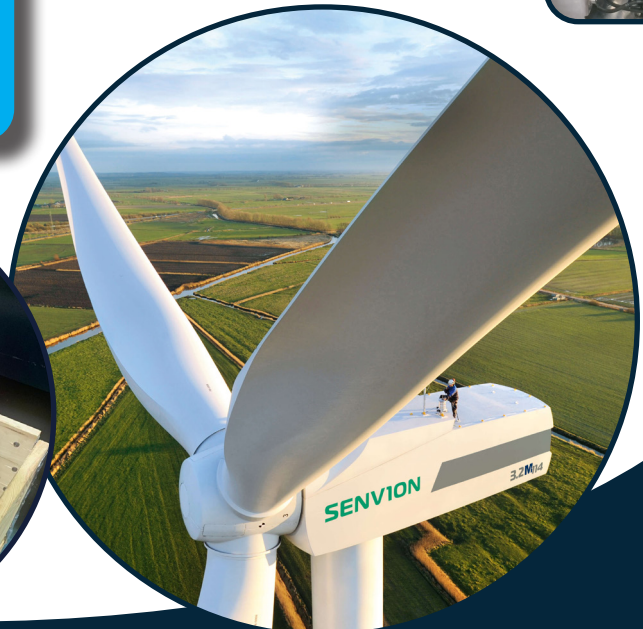
The most common failure modes are encoders, brush damage, connector damage and ring contamination.

Dust build up is common on the power rings from the metal graphite brushes. Gold wire slip rings also suffer from contamination and broken brushes. As a slip ring manufacturer BGB has a developed supply chain and engineering capabilities to recreate broken components, including replacing brushes, bearings and seals.

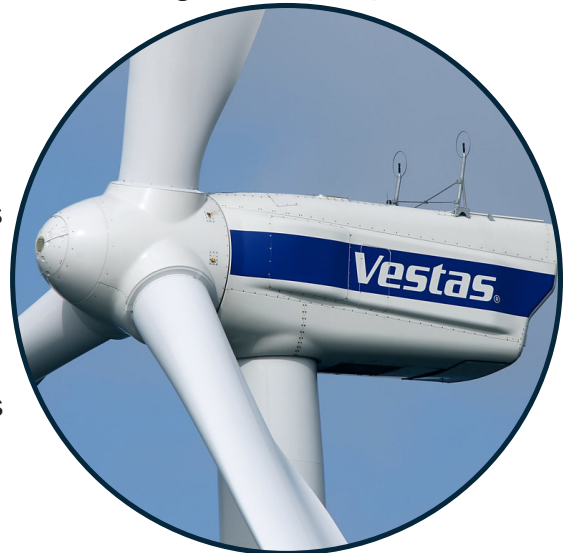
The NEG Micon slip rings were designed with circular economy in mind, and most slip rings, despite their age, see good results from a refurbishment service. The typical failure mode is oil ingress from the gearbox and with access to all components, BGB is able to offer a high yield, low cost service with a fast turnaround.

The Vestas generator slip rings often exhibit wear damage from copper brushes, earth ring damage or general wear. As the original manufacturer, BGB has the ability to replace all wearing and structural parts with new if required.

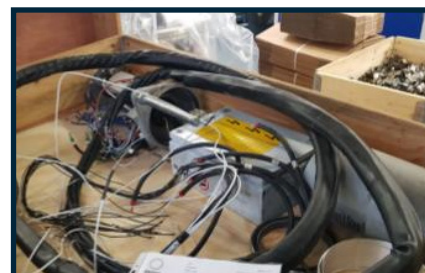
**BEFORE**

The GE pitch control slip rings use gold wire contact technology, carbon and even fibre optics. We are able to repair even the most damaged slip rings. Typical failure modes for slip rings are oil ingress, carbon dust build up, damaged bearings from standing and broken brushes. We can offer a high yield, low-cost service with a fast turnaround. We also carry stock of certain units so that downtime is minimised whilst you wait for your repair.

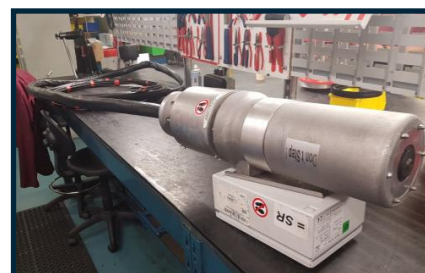
**AFTER**

Power and signal cables can often give high resistance readings so BGB changes where required so that the slip ring can easily be connected back into service.
