Refurbishments: **Wind**

Enercon – Slip Ring Repair

REPAIR CATEGORY: Pitch Control Slip Rings

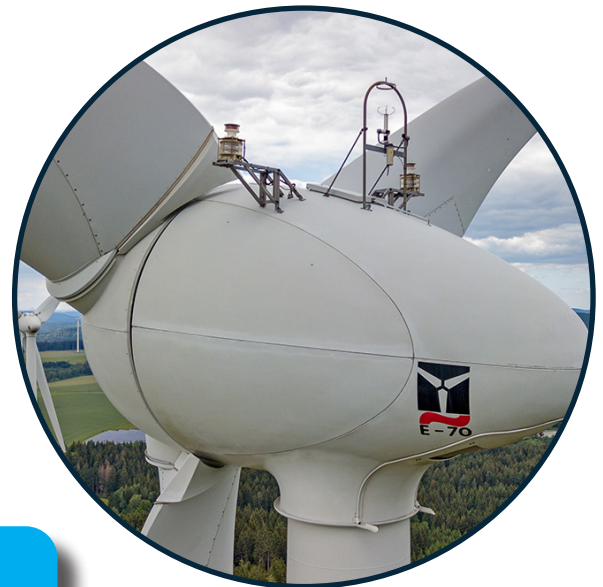
The most common failure modes are encoders, brush damage, connector damage and ring contamination.

Dust build up is common on the power rings from the metal graphite brushes. Gold wire slip rings also suffer from contamination and broken brushes. As a slip ring manufacturer BGB has a developed supply chain and engineering capabilities to recreate broken components, including replacing brushes, bearings and seals.

BGB leverages over 30 years in the wind industry. Within our unmatched skills and supply chain we have the ability to restore failed slip ring units recovering structural elements and replacing wearing and damaged parts.
